# City of Newport News, Virginia Shoreline Inventory Report Methods and Guidelines

Special report in Applied Marine Science and Ocean Engineering No. 414 of the Virginia Institute of Marine Science

# City of Newport News – Shoreline Inventory Report

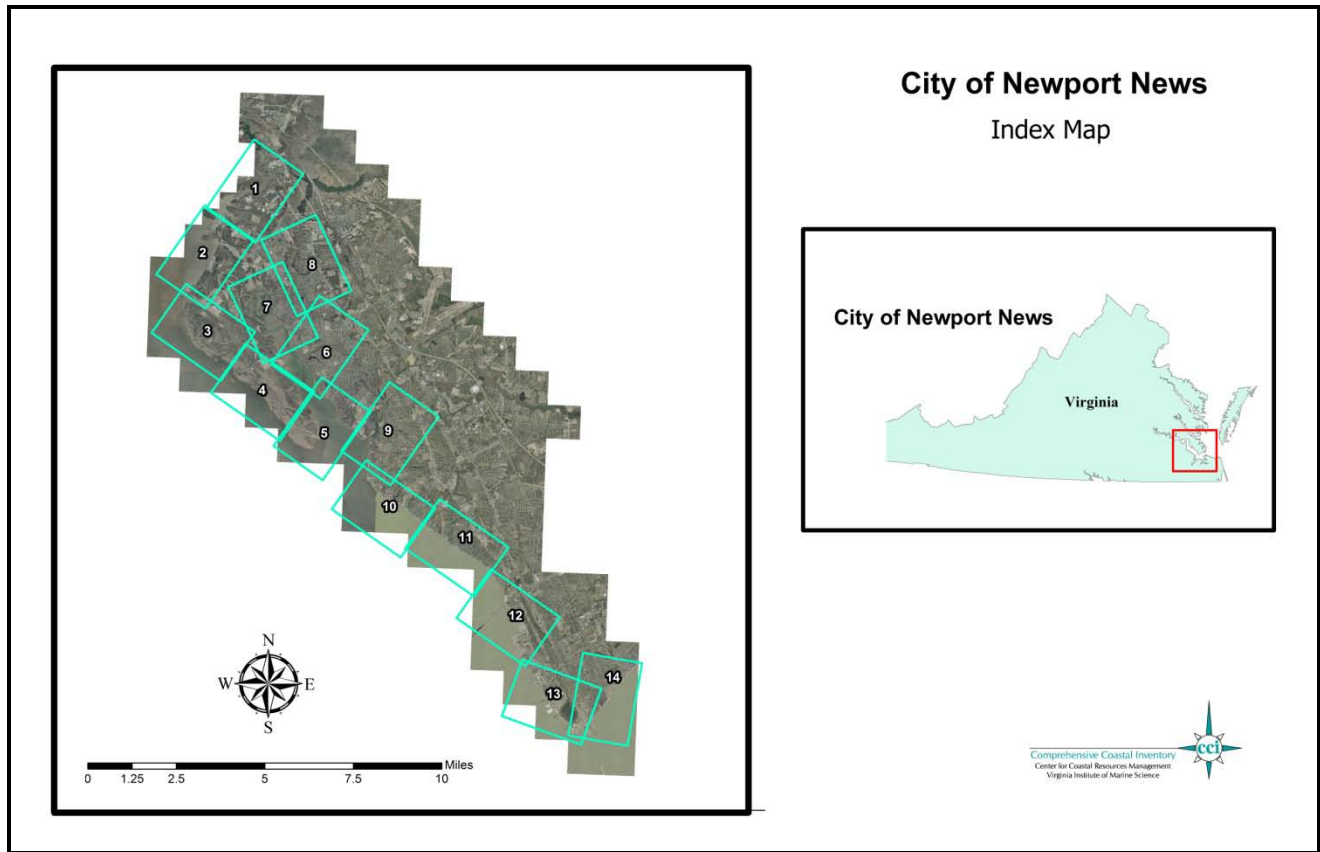
Figure 2. Map index for the City of Newport News

For publication purposes the city is divided into a series of maps. Maps are scaled at 1:12,000 for publication at 11x17. Scale will vary if printed at a different size. There are 14 maps for the City of Newport News determined by the city's geographic size and shape. For each map there are four plates (plate 1a, 1b, 1c, 1d, etc.), for a total of 56 map compositions. On the website (Figure 1), an index is provided to help users locate the area of interest and view the orientation of the maps to each other (Figure 2). Each plate can be individually selected and viewed from the plate list along the left hand column of the index page.

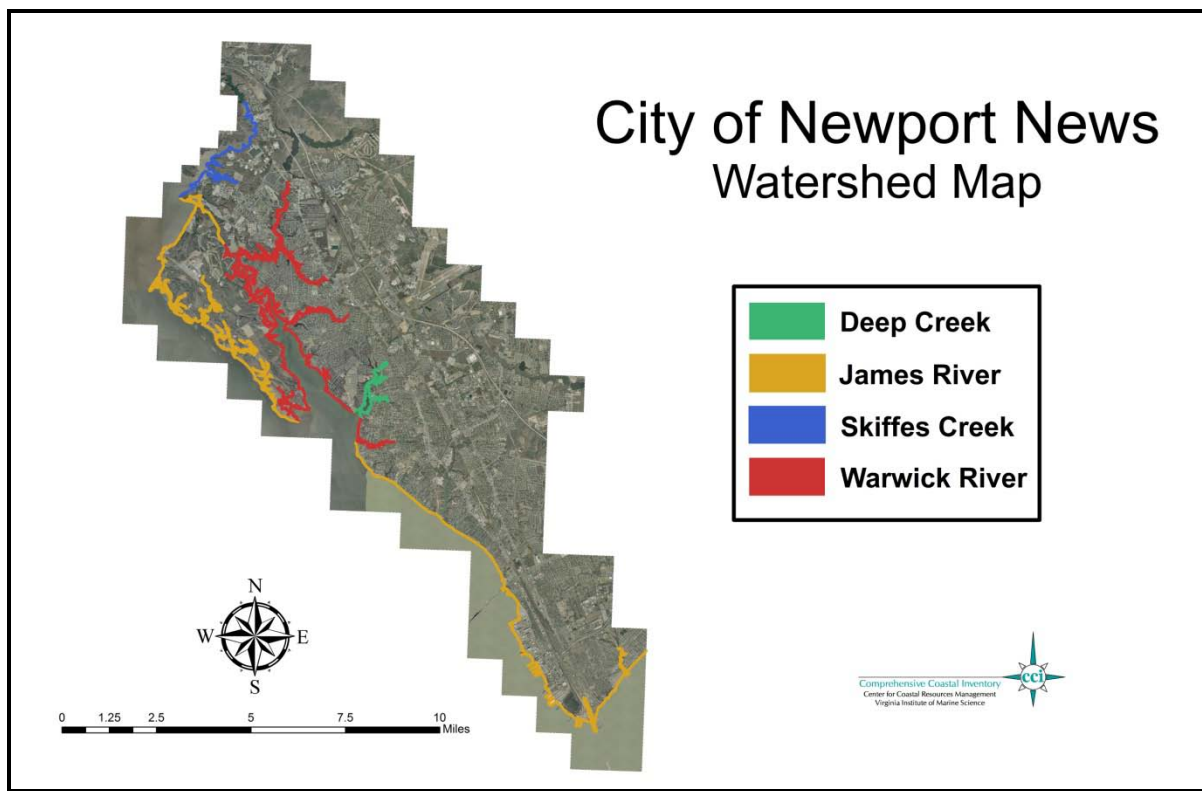
Figure 3. Delineation of City watersheds used for data reporting

Tables 4, 5, and 6 quantify features and conditions mapped along the rivers using frequency analysis techniques in ArcInfo. The values quantify features by river system (Figure 3). For linear features, values are reported in actual miles surveyed. Point features are enumerated. The total miles of shoreline surveyed for each tributary is reported. For the city, a total of 91.93 miles were surveyed in the field. Approximately 64.92 miles of shoreline were surveyed using remote sensing techniques. Figure 4 illustrates where field surveys were conducted and where remote sensing techniques were applied. The majority of these miles were places where navigation was restricted. Table 6 reports the survey dates, miles surveyed, and miles surveyed remotely.

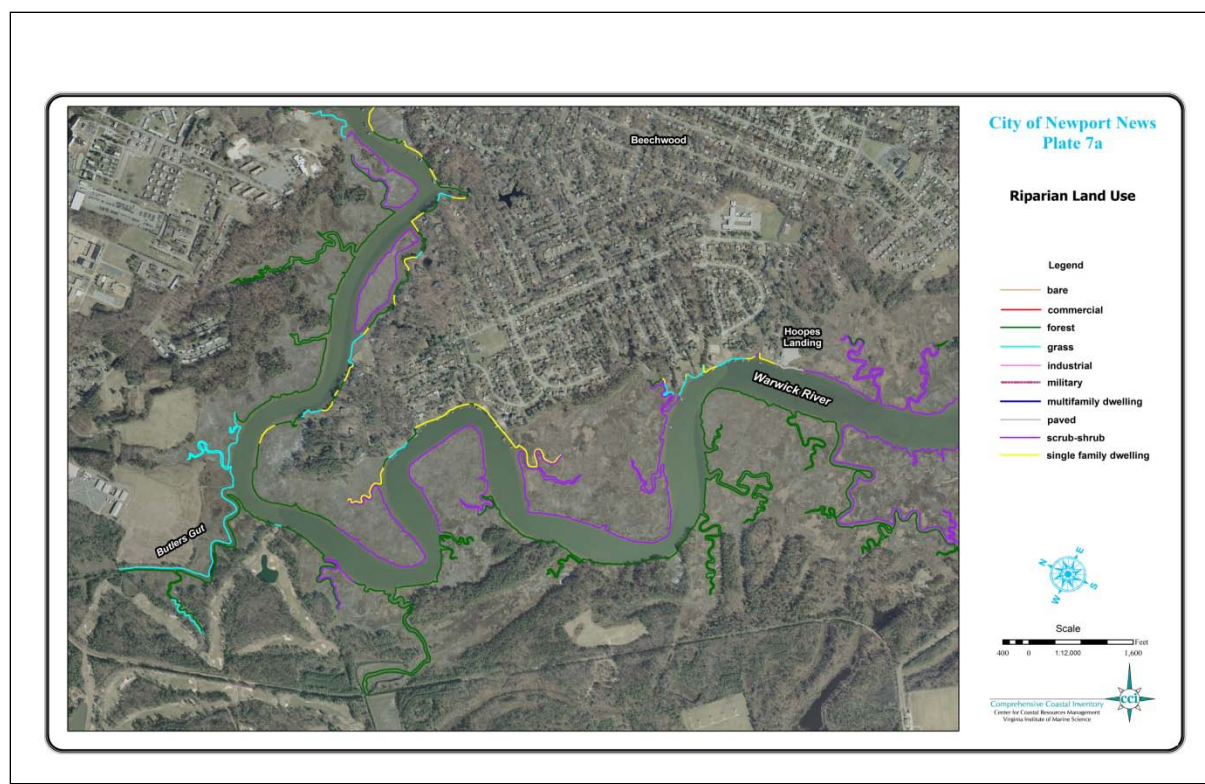
Figure 6. Sample riparian land use map for the City of Newport News

Plate A describes the riparian land use as color-coded bars along the shore. The background imagery is natural color VBMP imagery at a publication scale of 1:12,000. Users should note that the imagery is sometime rotated in order to meet the scale requirements. This means that “north” is not always to the top of the page.

Once you determine which plate you want, the scroll down menu on the left has links to the four part series for each plate (Figure 5). At the top of the scroll bar Riparian Land Use (plate a) is first. You can scroll down to see links to maps illustrating Bank Conditions (plate b), Shoreline Features (plate c), and Natural Buffers (plate d). The content and details of the four part plate series was described in detail in Chapter 2. The actual map will come up when you click on the plate number. For example, Figure 6 is the riparian land use map for plate 7. Figure 7 is the map illustrating bank conditions for plate 7. Figure 8 shows all the shoreline features for that same area, and Figure 9 the natural buffers associated with that section.

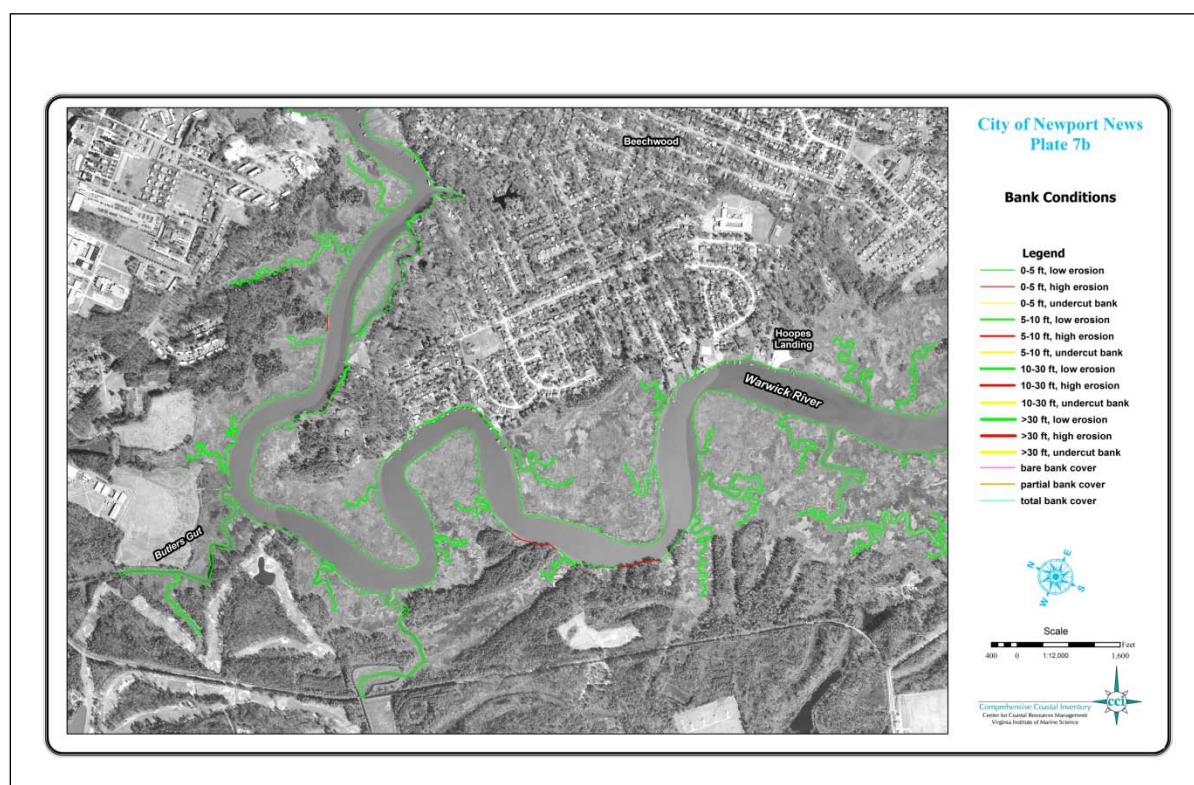
Figure 7. Map illustrating bank conditions for plate 7 in the City of Newport News

Plate B depicts the condition of the bank; specifically bank stability, bank cover, and bank height. The colors light green, red and yellow are used to report if the bank presents low erosion, high erosion, or undercut, respectively. The thickness of the line reflects the bank height; where the thickest lines designate the highest banks (> 30 feet). The bank cover is

reported using the colors fuchsia, orange, and aqua, to designate bare, partial or total cover, respectively. Plate B uses a grey scale version of the natural color image for the backdrop.

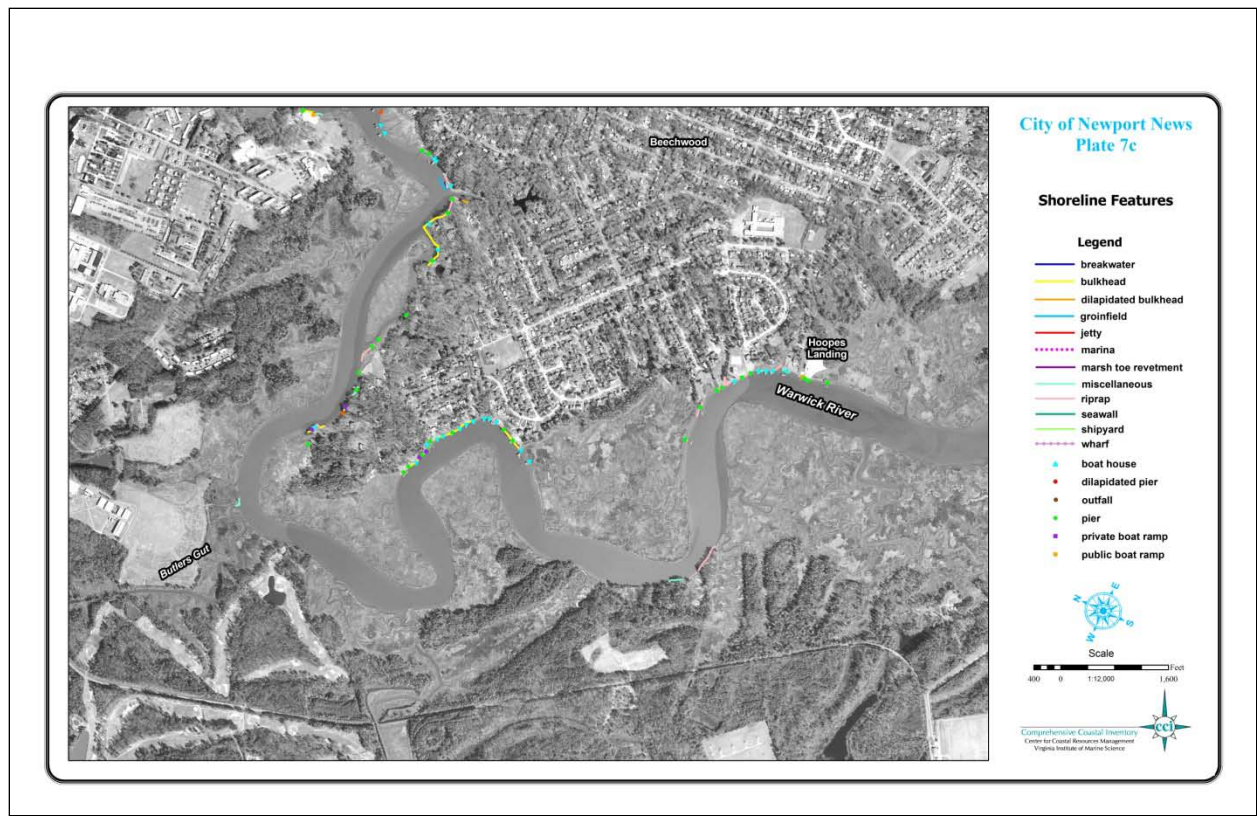
Figure 8. Map illustrating shoreline features for plate 7 in the City of Newport News

Plate C combines water use, access and shoreline protection structures in a composition called Shoreline Features. These are generally anthropogenic alterations constructed to gain access to the water or to stabilize a shoreline from existing and future bank erosion. Linear features, described previously (Table 3), are mapped using color coded bar symbols that follow the orientation of the shoreline. Point features use a combination of colors and symbols to plot the positions on the map. Gray scale imagery is used as a backdrop.

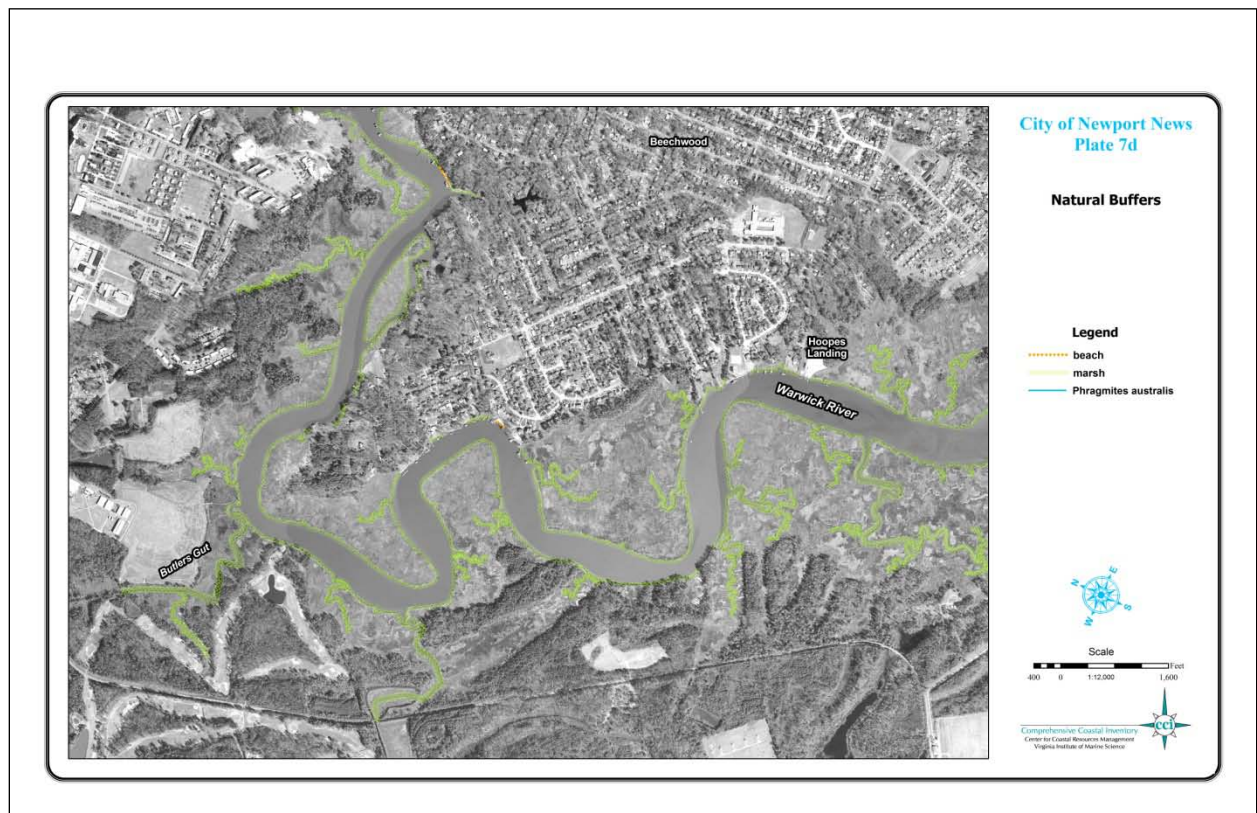
Figure 9. Map illustrating natural buffers for plate 7 in the City of Newport News

On Plate D, a pattern of small colored circles along the shoreline describes any natural buffers present. These are limited to marshes and beaches. Orange solid circles represent the presence of beaches and green open circles represent marshes. The presence of the invasive species *Phragmites australis* is designated with a blue line shown behind the shoreline.
